PHOTOGRAPHIC INTELLIGENCE REPORT

ARSENALS AND ARMAMENTS PLANTS

TAI-YUAN, CHINA

CIA/PIR 75029

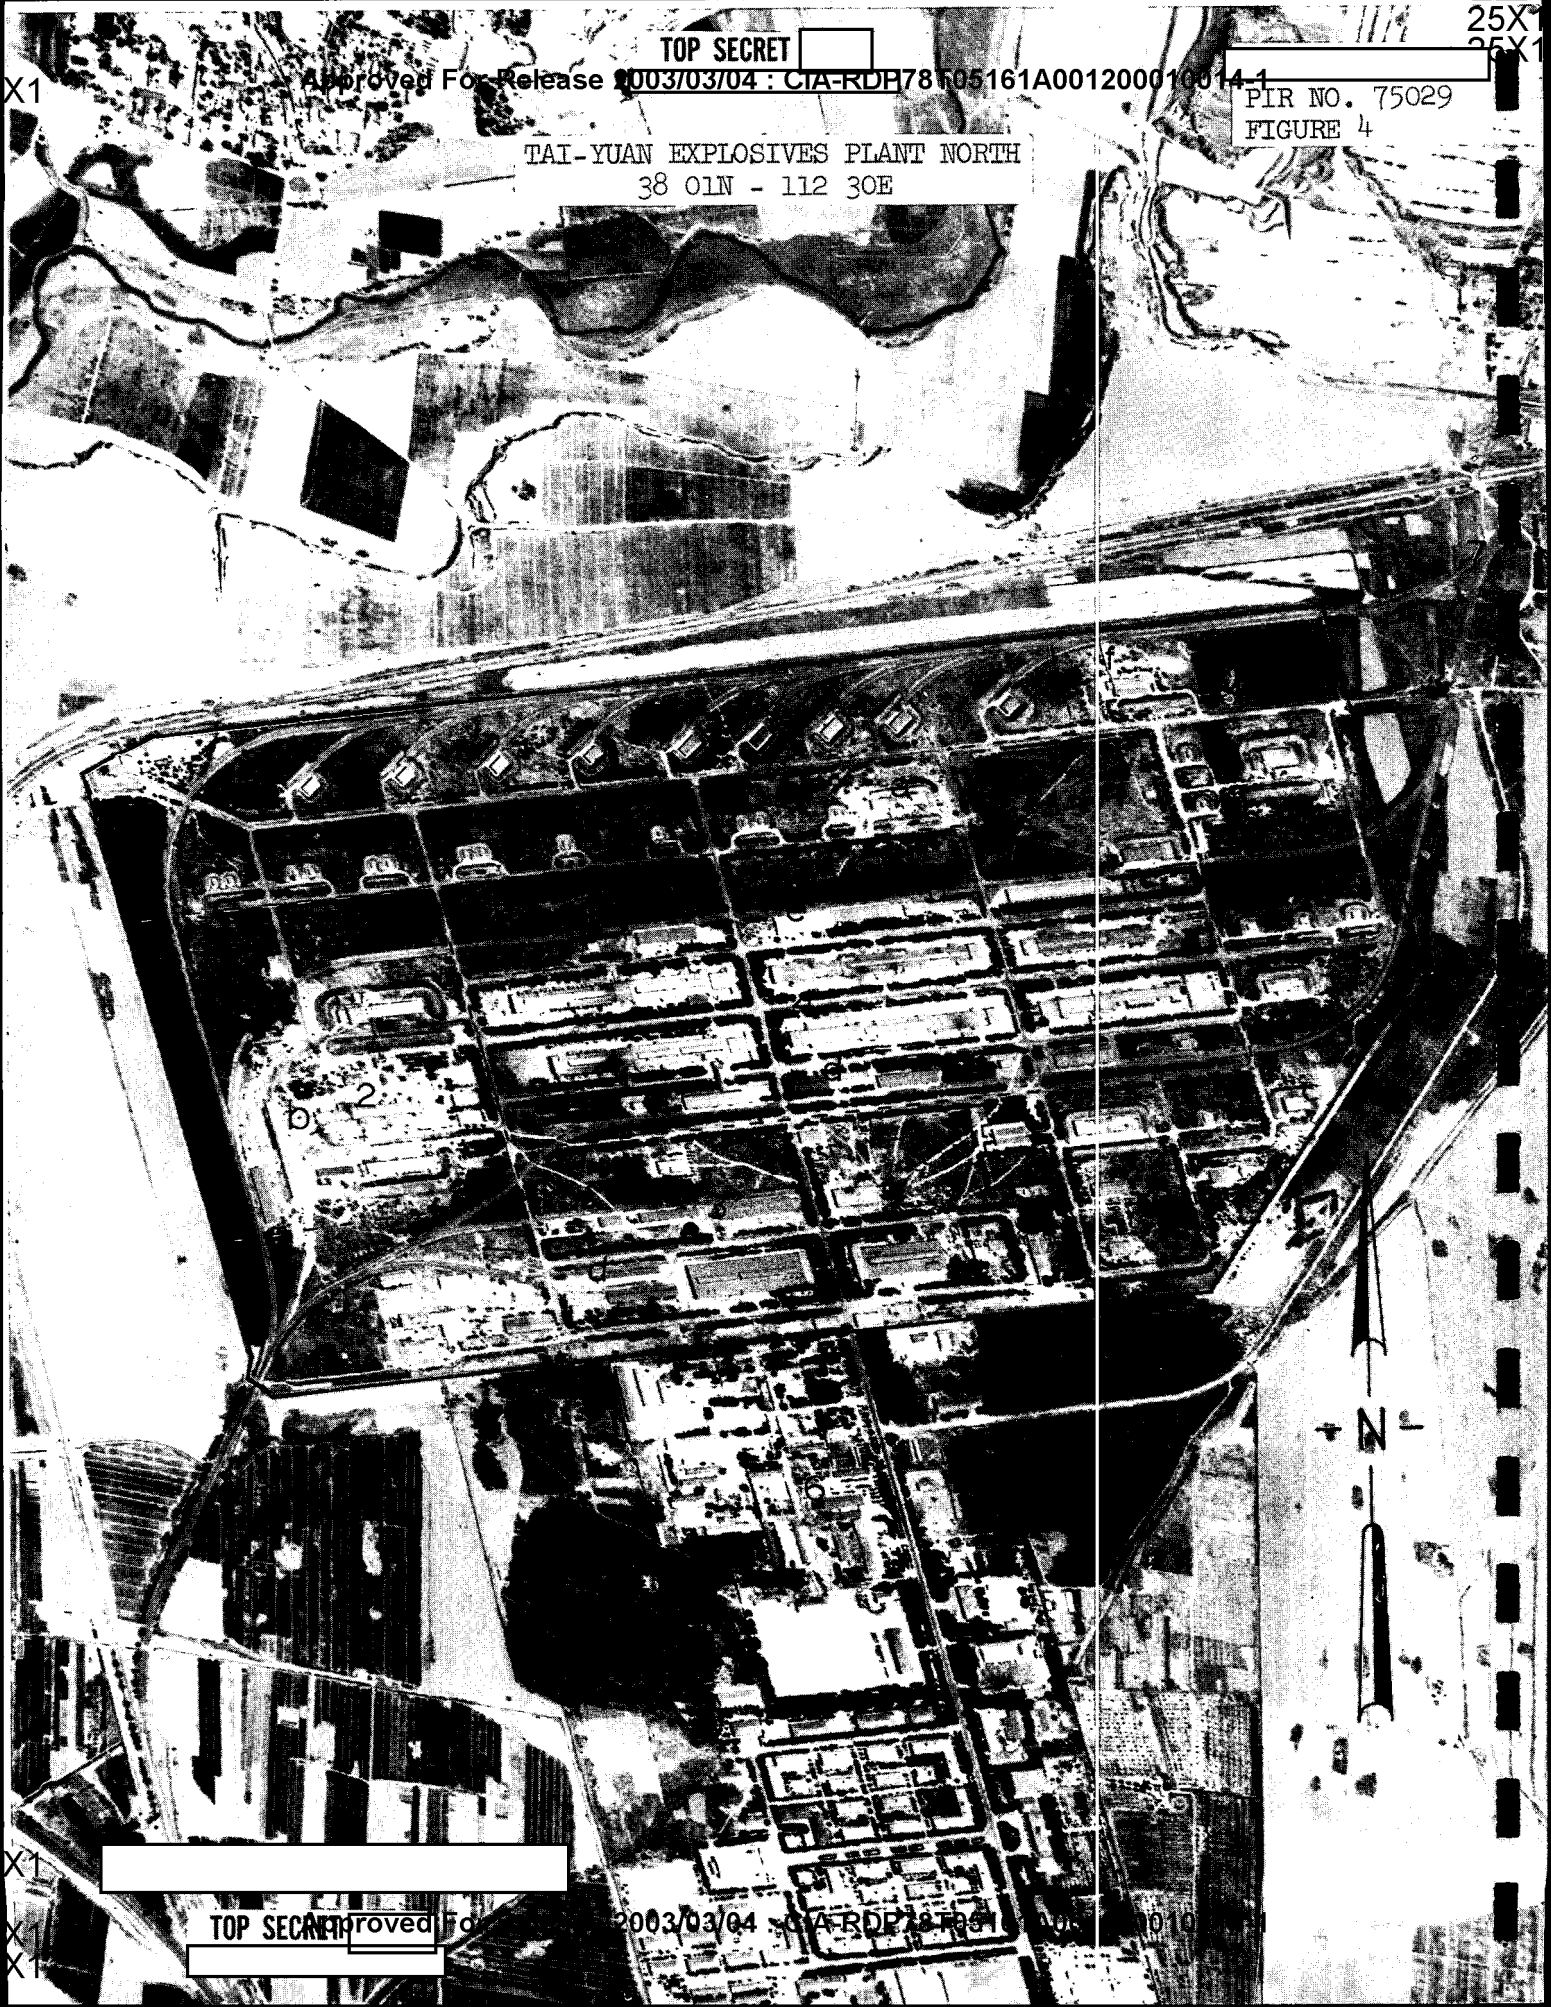
FIGURE 4

The production and storage areas consist mostly of heavily revetted, protected, and dispersed buildings, typical of explosives handling and processing areas. The following item numbers are keyed to Figure 4.

- (1) Explosives storage section. Contains nine revetted rail served buildings and thirteen small revetted buildings.
- (2) Probable high explosives processing section. Contains a heavily revetted building connected by pipeline to a small building outside the revetment, a rail served central support building, and a partially revetted building on the south side of the section.
- (3) This section contains large warehouses for non-explosives material, a possible wood-working shop, a probable maintenance shop, and other plant support facilities. The western portion of this area contains a small unidentified group of buildings, and one bunkered structure.

(4) Major explosives processing section. Consist of six long narrow buildings possibly housing individual production lines. Rail served warehouses and other smaller support facilities are located adjacent to each of these production buildings, and in one case is connected by conveyor to the production section. Three of the buildings have protected baffled entrances and two have roofless rectangular sections which extend outward from the wall, enclosing an area of [redacted]. These appear to have been built by extending interior blast walls, [redacted]

(5) Explosives processing section. Facilities include seven separate revetted or partially revetted explosives processing buildings, with small adjacent revetted rest houses and several miscellaneous non-revetted structures.

(6) Support facilities. Lying to the south of the main plant are a number of associated support facilities. These include administration buildings, workers housing, a motor pool, small shops, and a possible foundry.

(7) Rail line. This rail line extends approximately two nautical miles east to a secured explosives storage area.

TAI-YUAN EXPLOSIVES PLANT NORTH
38 01N - 112 30E

When first observed [redacted] this installation was in the late stages of construction. However, steam and other utility lines were not laid and several buildings, mostly in the support area (section 6) were under construction. The installation appears to be complete and operational [redacted]. Only minor additions to the plant have been made since that date. An explosives processing building (a) was erected [redacted] replacing a similar but smaller building. A permanent covered walkway (b) was constructed during this same period. [redacted] a small possible laboratory building (c) and three probable warehouses (d) were built.

[redacted] the only further additions were an additional warehouse (e), three small buildings and a small unidentified tank-like structure in section 2, and a covered walkway (f) from the rail line to a revetted probable shipping and receiving building.

This installation did not appear to be operational [redacted]. The plant facilities appeared complete on coverage [redacted], but due to the poor quality of the photography, it is difficult to determine if the plant was in operation, although a probable rail car adjacent to an explosives [redacted]

storage building (section 1) suggests that some production may have been in progress. On excellent [] coverage [] definite indications of production are evident such as roof stains on several of the buildings, eleven rail cars on plant sidings, smoke or steam near the wood-working shop, and one probable truck and several small unidentified objects on the plant roads. On all subsequent coverage, similar signs of production activity are noted, but the actual level at which the plant has been operating cannot be accurately estimated.

Tai-yuan Explosives Plant North is a large explosives processing and loading installation. The lack of tankage, above ground piping, and acid areas indicates that there is no explosives manufacture. The numerous separate processing areas for explosives and the general appearance of the plant suggests that it was designed for large scale production of several different explosive components. Propellant loading is a possible function of this plant, in association with the manufacture of double base propellant at nearby Tai-yuan Explosives Plant South.

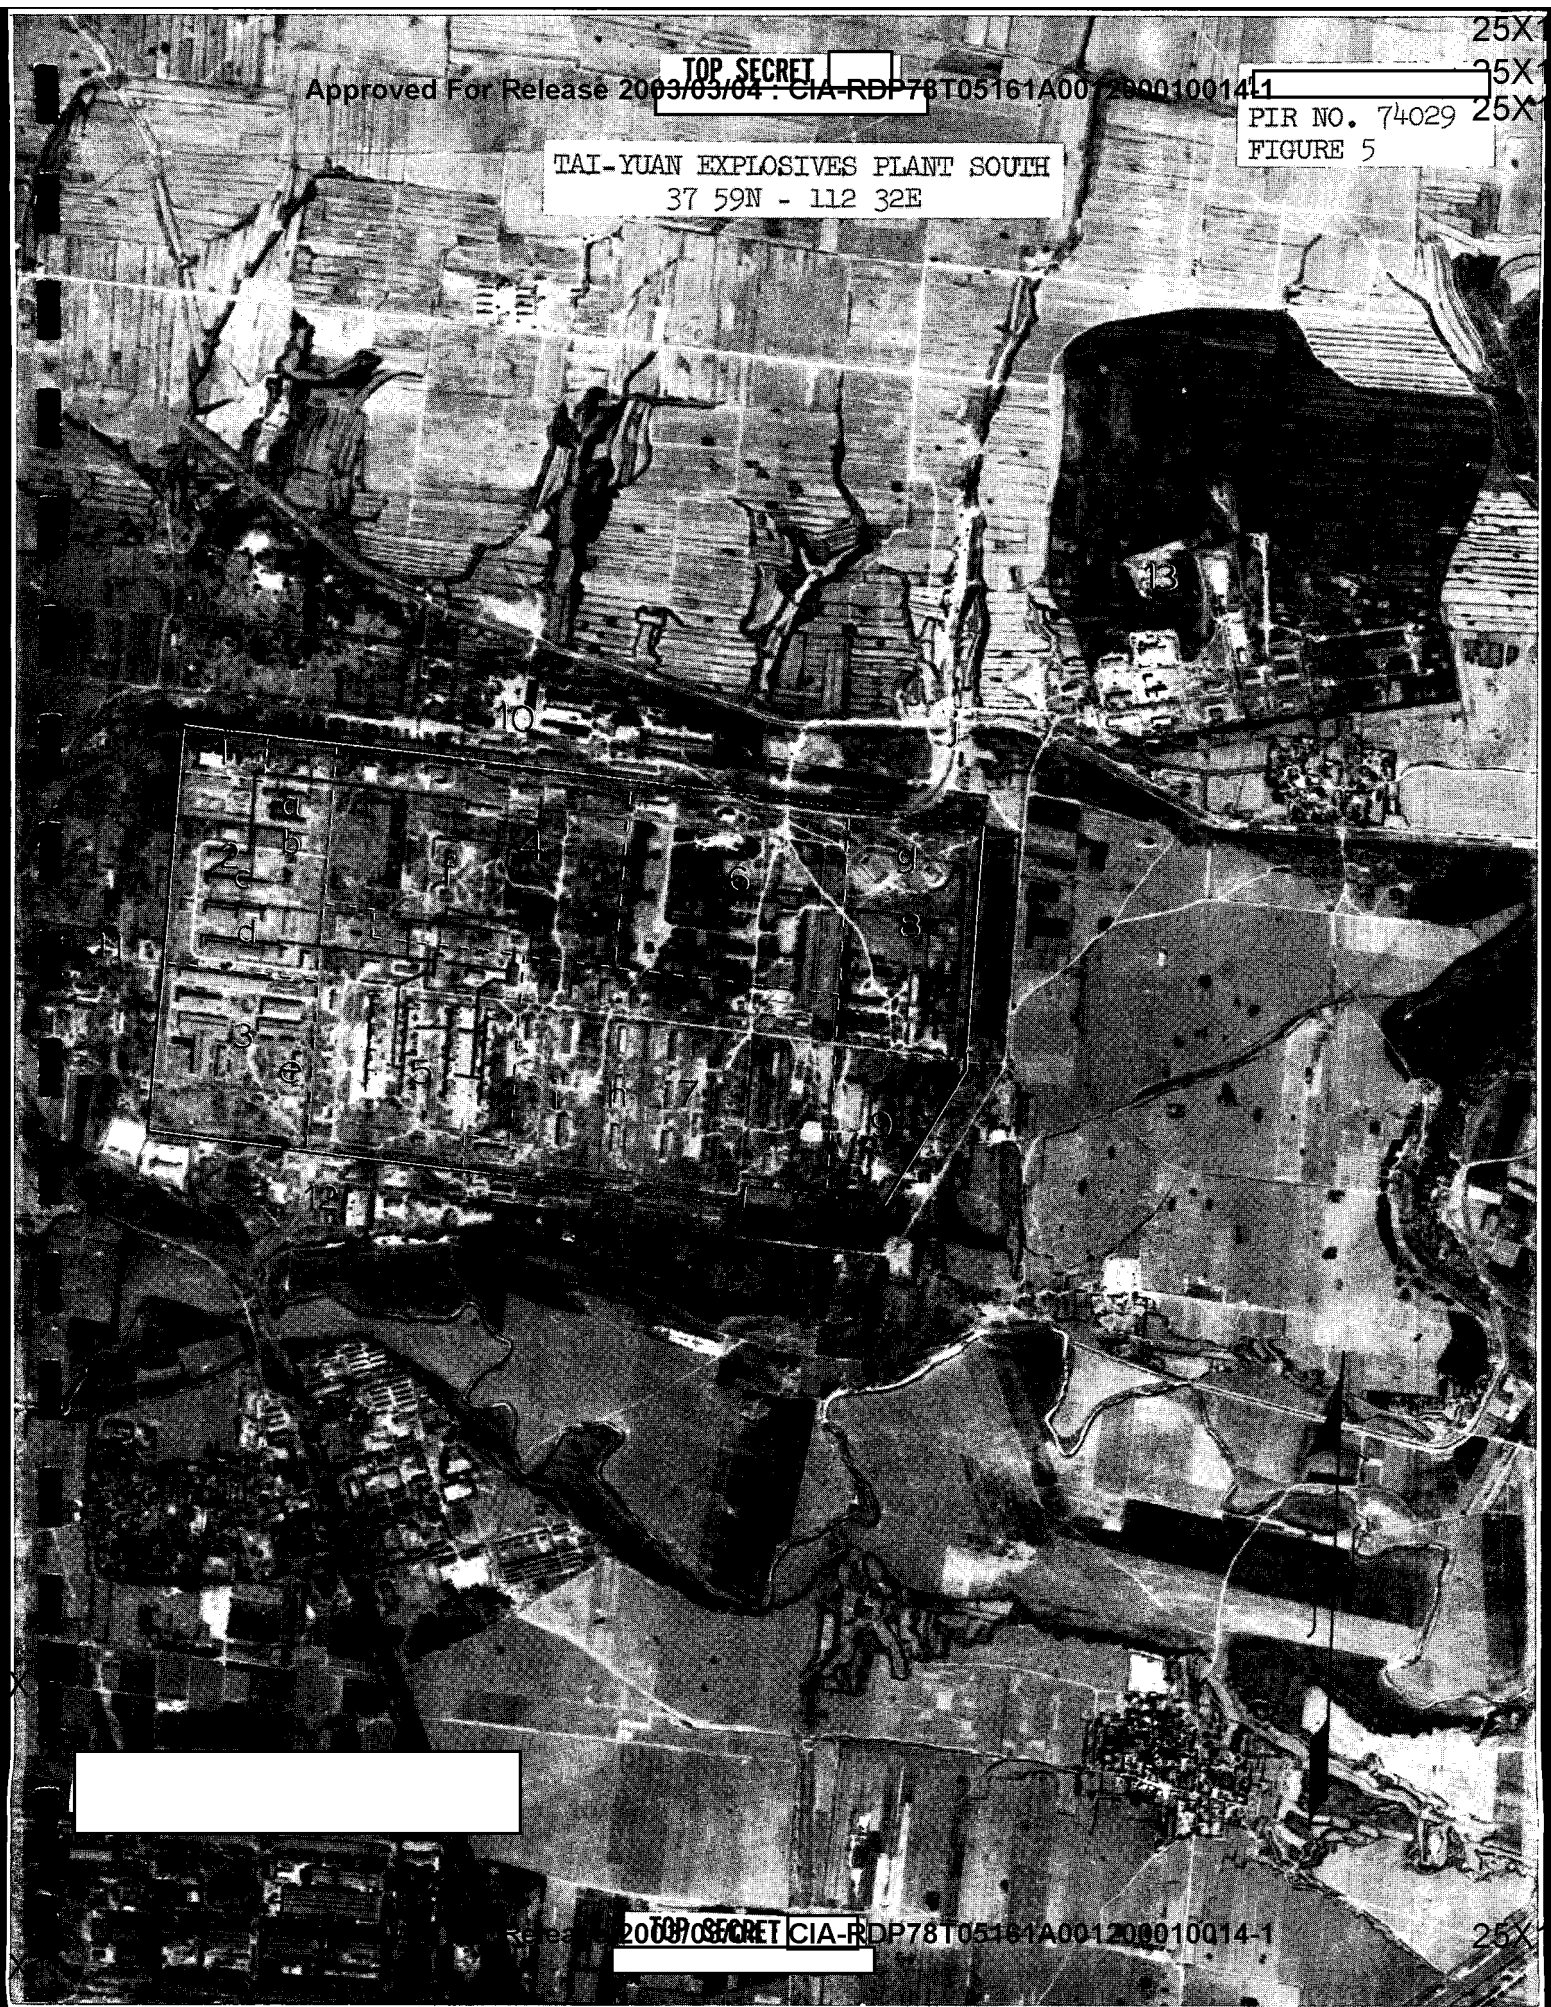
PIR NO. 74029
FIGURE 5

Many buildings at this plant are generally heavily protected or dispersed; they are connected by above ground pipelines and covered walkways. Storage tanks are noted mainly in the shipping and receiving section. These features are typical of explosives production and handling plants. The following item numbers are keyed to Figure 5.

- (1) Unidentified processing section.
- (2) Nitrocellulose production section. Facilities include a possible acid plant (a) with nearby liquid and probable cellulose receiving and storage (b); possibly nitration building (c); and pyro processing buildings (d).

(3) Fabrication section. Facilities include several large shop-type buildings, possibly for processing of non-explosive components; a long probable receiving and warehouse building; and a possible laboratory building (e) with a small adjacent bunkered structure.

(4) Nitroglycerine production section. Consist of rail served raw materials receiving and storage buildings and one completed and two partially constructed nitroglycerine production lines.

(5) Double-base powder production section. The non-solvent process is probably utilized. Three of the four large processing buildings are apparently complete, as well as the mixing and preparation buildings in the north part of this section.

(6) Abandoned construction. No attempt has been made to complete the early construction in this area, which remains basically unchanged since observed [REDACTED]. The layout suggests that an explosives processing section was planned in this area.

(7) Probable drying and finishing buildings, with alternating rest houses, occupy this section.

(8) Three processing buildings, possibly associated with the nearby rocket test facility and two large probable product storage and shipping buildings (revetted and rail served) are located in this section.

(9 and 10) Maintenance and storage sections.

(11) Shipping and receiving section. Rail served shipping and receiving point with warehousing and open storage. Immediately south of this separately fenced area is a water treatment facility.

(12) Support section. Immediately south of the main plant is a area containing administration buildings, laboratories and possible shops. Barracks and probable construction support buildings lie east of the administration area; several of these have been removed since the earliest coverage.

(13) Ballistics and solid propellants test facility. Two test ranges and associated facilities occupy the southern portion of this separately secured section. Facilities to the north of the ballistics test area include one test cell, another building containing two possible test cells, and probable missile checkout and support buildings.

TAI-YUAN EXPLOSIVES PLANT SOUTH
37 59N - 112 32E

When observed on earliest coverage [] this installation was in the mid-stage of construction. All major processing sections were under construction and many buildings appeared to be nearly complete. Construction progress has continued at a fairly slow pace since then. [] buildings in the nitrocellulose section appeared nearly complete, the west nitroglycerine line (f) was well advanced, work was continuing on explosives processing and propellant test facilities, and overhead pipelines and covered walkways were under construction. Excellent coverage [] revealed: additional construction on walkways, pipelines, and conveyors, probable completion of the west nitroglycerine line, the construction of two large revetted storage buildings (g) and further construction at the solid propellants and ballistics test facility. One row of buildings (h) in the probable drying and finishing section was probably near completion. [] progress continued. A rail spur was constructed along the north side of the plant, serving the areas of nitrocellulose and nitroglycerine production and the large explosives storage buildings. A spur was also constructed into the central portion of the nitrocellulose section. Improvements were made on the plant road network and a area of new construction (i) was present in the probable finishing and drying section. Construction in this area was continuing in [] and a rail spur has been extended into an area of new construction (j), directly west of the test facility. This may be an explosives storage area, when completed.

Rail tank cars have been noted on sidings in the plant area on coverage [] However, the rate of progress in plant construction suggests that the plant probably could not have been in operation until the [] and then probably only on a test or "batch" basis. Construction, especially on tankage, pipelines, and conveyors in the nitrocellulose area, [] suggests that any production prior to [] was on a small scale. Roof stains at the probable acid plant and the general stage reached in plant development indicates that the installation is operational by [] However, [] construction is still occurring at the west end of the explosives finishing and drying section and on the probable explosives storage facilities.

The solid propellant and ballistics test facility appeared near completion on [] coverage, and only minor construction has occurred since that date.

The two south nitroglycerine lines and an explosives processing area (section 6) have been left unfinished.

Tai-yuan Explosives Plant South is a large double-base propellants production complex. The rate of progress in erecting this plant has been very slow and portions of the original construction have apparently been abandoned.

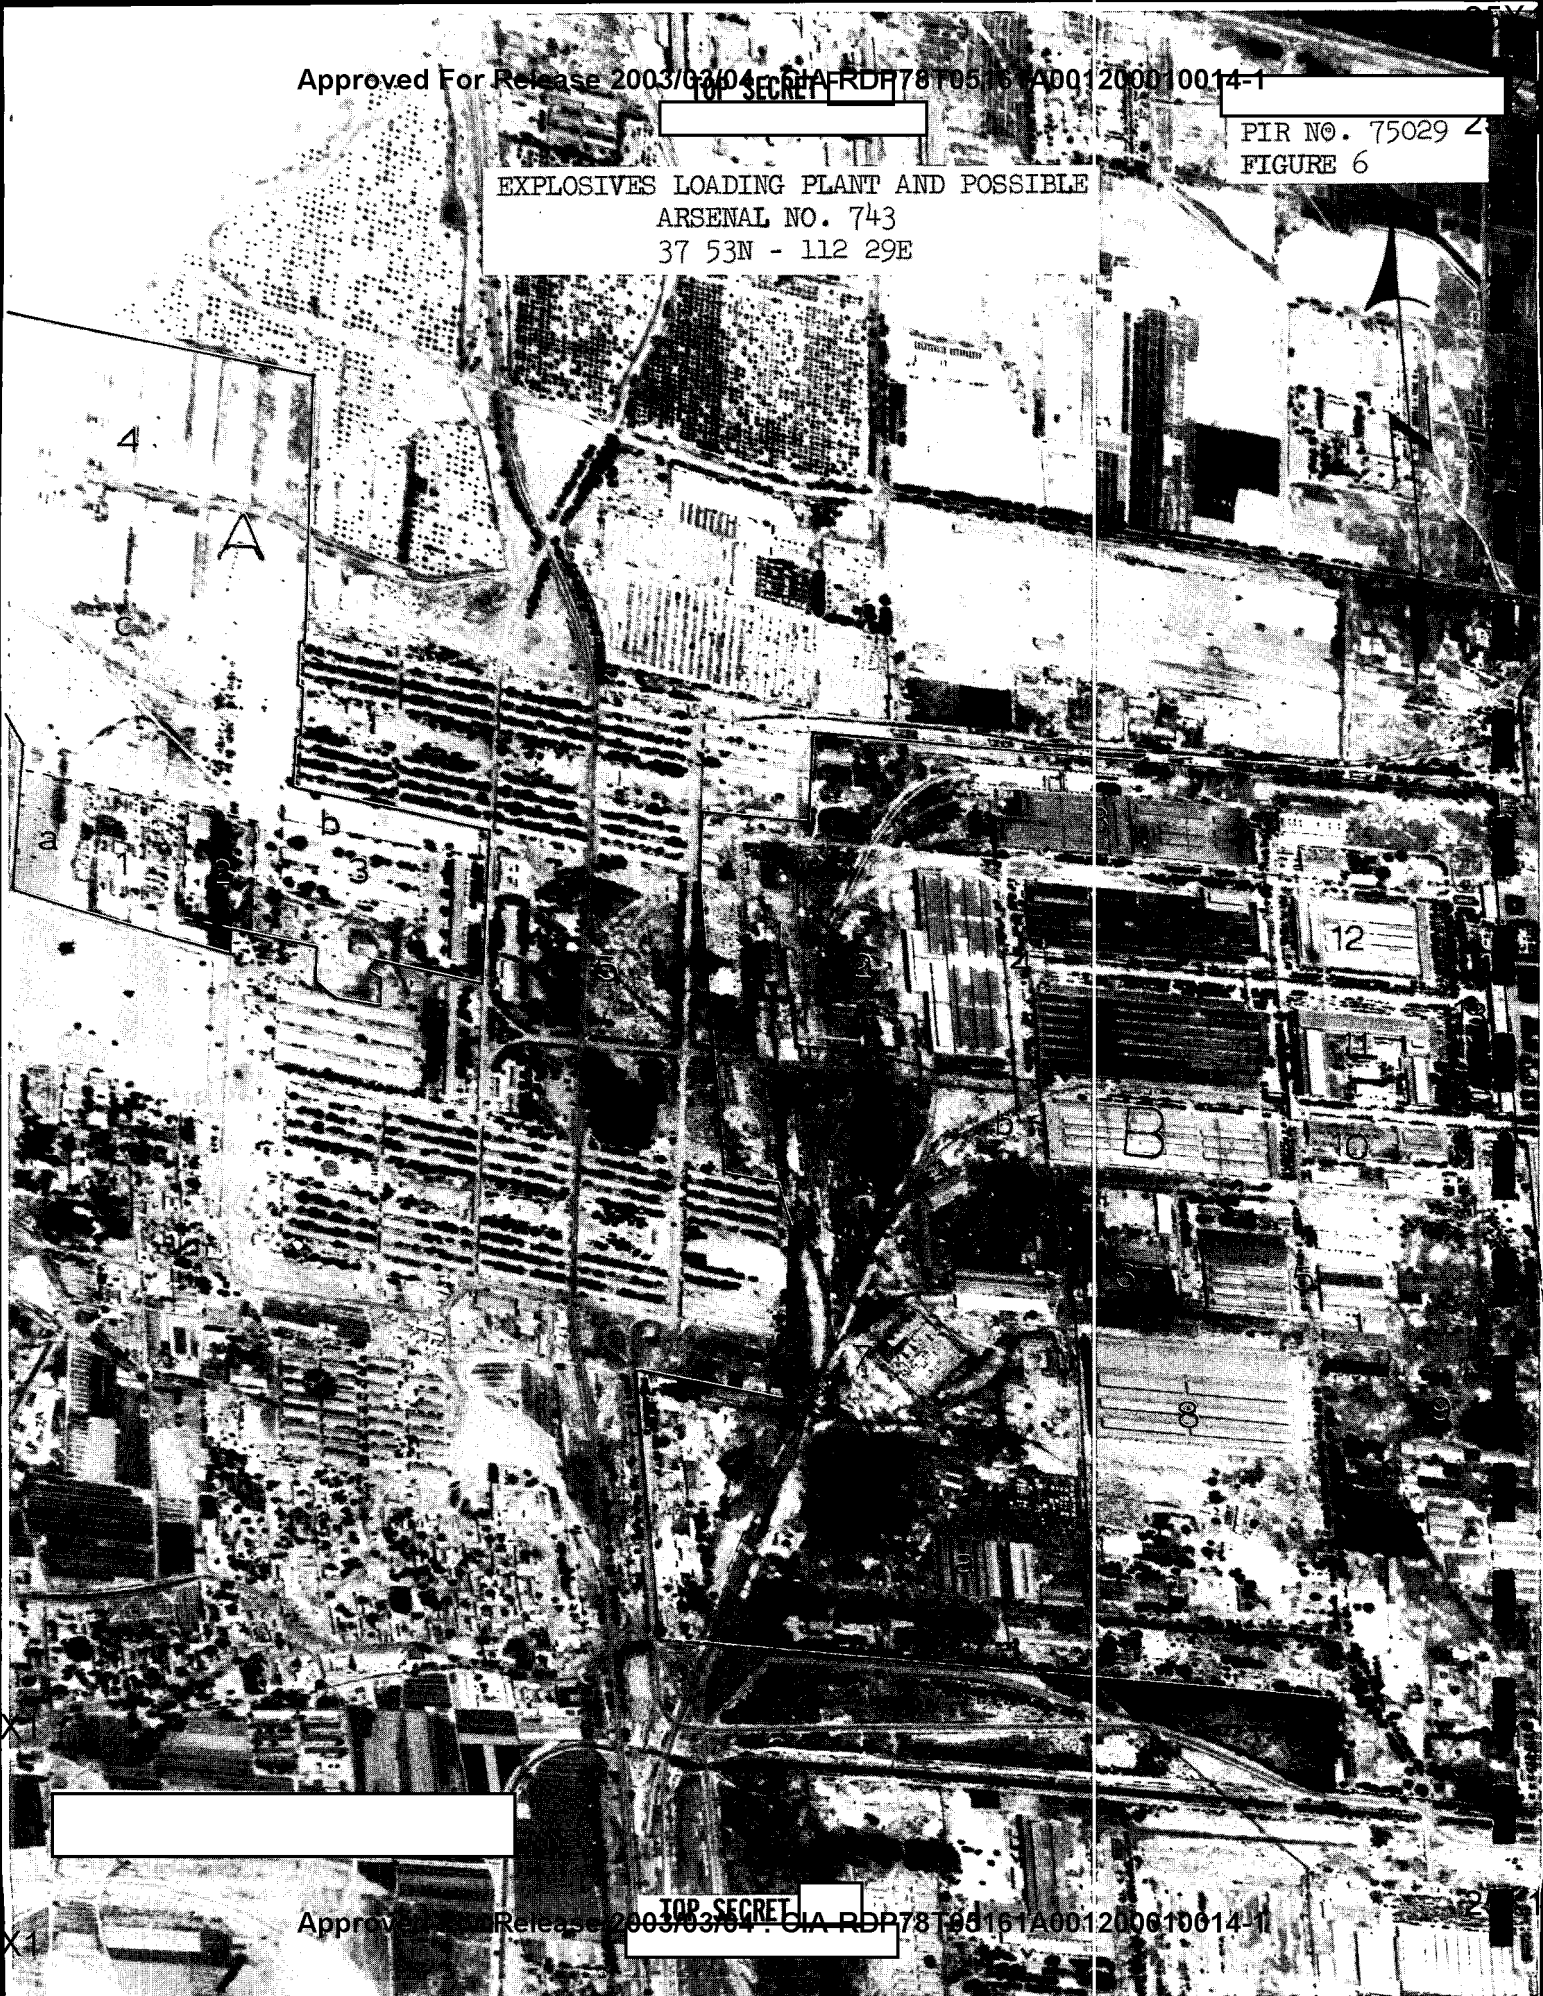
PIR NO. 75029 2
FIGURE 6

This installation appears to only contain facilities for processing and loading of explosives. Both the processing and storage areas are characterized by small heavily revetted and dispersed buildings. The following item numbers are keyed to Figure 6, Section A.

(1) Three dispersed and heavily barricaded identical pairs of probable explosives processing buildings are located in this section. A small revetted pit at annotation (a) added []
[] may be utilized for destruction of faulty material.

(2) This area contains seven small dispersed probable processing buildings. Barricades have been erected between the buildings and the section has been heavily planted with trees.

(3) Four long narrow buildings with an earthen wall along their south side and a large administration building are the main structures in this area. Several protected explosives processing buildings, a very small possible boilerhouse, and two service buildings are located south of this main group of buildings. A small storage tank is also located in this area. The group of buildings immediately south of this plant are quite similar in appearance to the main buildings in area 3. However, they are not considered to be directly associated with this plant, because they are not within the plant fenceline and are very poorly secured.

(4) Eight small revetted magazines are located in the northwest corner of this section. Other features include: a group of abandoned earth mounded kilns and a small unidentified building.

(5) Immediately east of the main gate are four administrative type buildings which may be associated with this plant, but are more likely to be public buildings serving the nearby housing areas.

The predominate structures at this site are large monitor roofed buildings, with high bays and furnace buildings, typical of fabrication industries. The following item numbers are keyed to Figure 6, Section B.

- (1) Gas or water gas retort building. The pipeline network indicates that the gas generated is used to fire furnaces throughout the installation. A water treatment area lies east of the retort building.

- (2) A large boilerhouse with one stack is located east of the retort building and is connected by a conveyor system leading to the nearby rail served coal piles.

- (3) Large rail served probable assembly building with an adjoining possible forge/foundry. A bridge crane is located north of this building.
- (4) These four large buildings are probably used as machine shops and for sub-assembly work. A possible forge/foundry section is present in the building with the two transverse monitors.

- (5) Probable shop buildings.
- (6) A probable foundry with warehouses and an open storage area directly to the west.
- (7) Power sub-station.
- (8) The largest building in the plant, and is possibly a fabrication/assembly hall.

- (9) South and east of the possible assembly hall are numerous small shops, maintenance buildings, and miscellaneous open storage.
- (10) Large probable foundry.

- (11) Unidentified C shaped building and a large shop.
- (12) Two small unidentified buildings.
- (13) Plant administration area, with three buildings at the entrance and several probable associated buildings located in the landscaped area east of the entrance.

EXPLOSIVES LOADING PLANT AND POSSIBLE
ARSENAL NO. 743
37 53N - 112 29E

Facilities at this installation have remained generally static since the first coverage [redacted]. One building (c) [redacted] has been dismantled [redacted]. An additional floor was added to one of the long narrow buildings (b) in area 3 [redacted]. An earthen wall on the north side of this building was removed [redacted]. During the [redacted] the previously mentioned possible burn area was constructed.

Indications of activity other than minor changes in plant facilities are scarce on all available coverage. No materials have been observed in open storage and few vehicles have been noted in the plant area. Trails to some of the processing and storage buildings appear unused. The level of operation is probably no more than moderate. The roof of one of the small barricaded processing buildings in area 2 is partially open on [redacted] coverage, suggesting an explosion or dismantling.

This plant is interpreted as being a small explosives processing and loading facility. The presence of small heavily protected processing and storage buildings suggests that the primary function is the handling of initiating compounds, in the loading of detonators and percussion elements. There is no indication that explosive compounds are made at this plant, although finishing of explosives shipped in from a manufacturing plant may occur in the small processing building in area 3. The addition on one of the group of long narrow buildings, and the removal of a portion of the earth banks from the north side of this group, suggests that they are probably no longer being used as loading lines. Their function may now be in the handling and assembly of non-explosive components.

This plant was in an advanced stage of construction when first observed [redacted] The only major building which didn't appear to be complete or nearly so, was the large possible assembly hall (8). This building appeared complete when observed [redacted] Other changes in plant facilities during this period included: completion of the foundry (10), the shop area (5), the addition of a small building east of the boilerhouse (2) and the bridge crane north of the assembly/forge-foundry building (3). [redacted] [redacted] only very minor changes are noted within the plant, such as additional warehousing (a), a small unidentified facility (b) which is connected by pipeline to the adjacent large shop/sub-assembly building, and new coal unloading and handling facilities in the gas plant (1) and boilerhouse (2) areas.

Coal and other materials in open storage and roof stains in the foundry area (6), indicate that minor production had taken place [redacted] However, most buildings were probably in the late stages of construction at that time. The plant appeared basically completed in [redacted] but the poor quality photography precludes an interpretation of the level of operation. Smoke and steam have been observed near the foundry (6) and at a couple of other points in the plant, on most missions. The configuration of the coal piles shows variation on comparative coverage. However, definite signs of activity, such as these, have been rare at many facilities within the plant. Crates and unidentified items are noted in open storage and small unidentified objects have been seen moving on plant roads. A few rail cars have been in the plant area on all missions. This installation has been in operation, probably at a low to moderate level of productive activity since at least [redacted]

The type of production from fabrication industries, such as this installation, is difficult to determine. Although several good satellite and overflight missions are available, no identifiable products have been observed at this site. The presence of heating and processing equipment in association with large fabrication and assembly buildings establishes the production and probable assembly of metal parts. However, on the basis of photography, it is not possible, at this time, to confirm or negate the possibility that this plant is engaged in armament production.
